The Railway from Pill Junction to Portishead in March 2015

A series of pictures
taken to record the status of the old line
following the major clearance operation

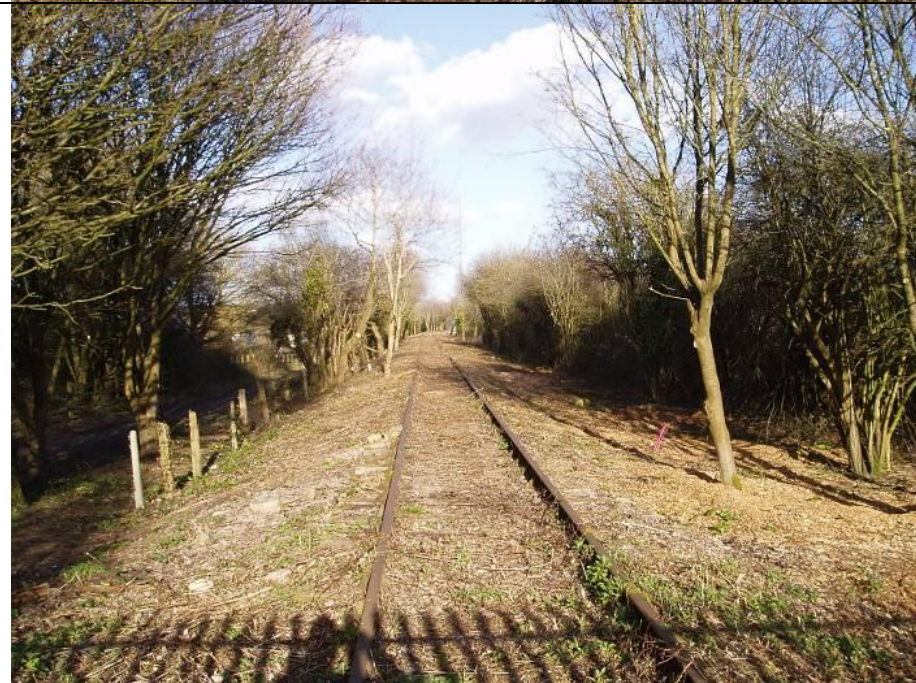
Photo 3260089

The view looking back towards the curve into Pill Junction.

Taken about 450 yds towards Portishead from Pill Junction, just before the M5 bridge.

The shadow shows there is a metal fence across the line but the fence on the left is not in a condition to prevent access to the line!

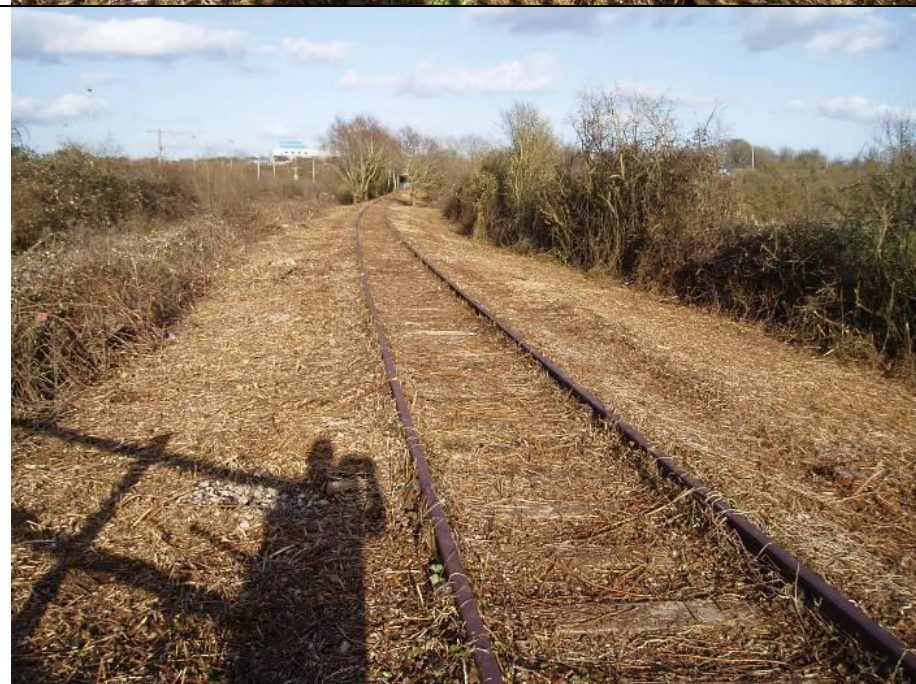
Photo 3260091

Looking back from near the Marsh Lane bridge, towards the bridge carrying the M5 motorway over the railway.

A motorway sign on its high posts can be seen to the left of the trees in the distance.

The throat of the M5 bridge can be seen, just left of centre.

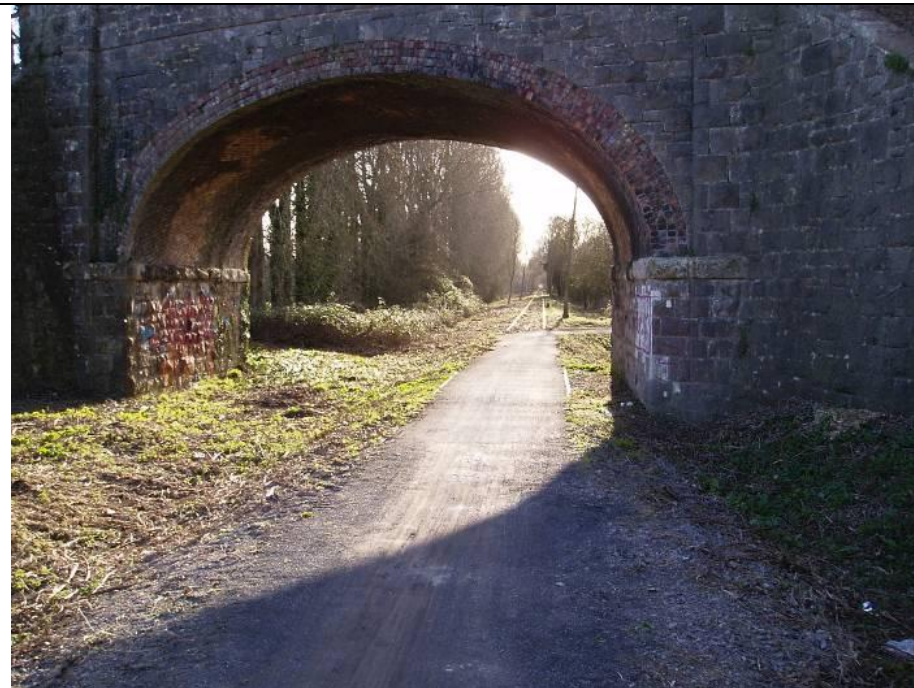
Photo 3260092

Next stop: Marsh Lane bridge

The view looking towards Portishead, where the cycle path comes in from the right.

The width of the bridge shows this was once a 2-track broad-gauge line. The bridge is typically GWR, massively built.

Note the rails and sleepers have been tarmac'd over. No problem with access to the line here!

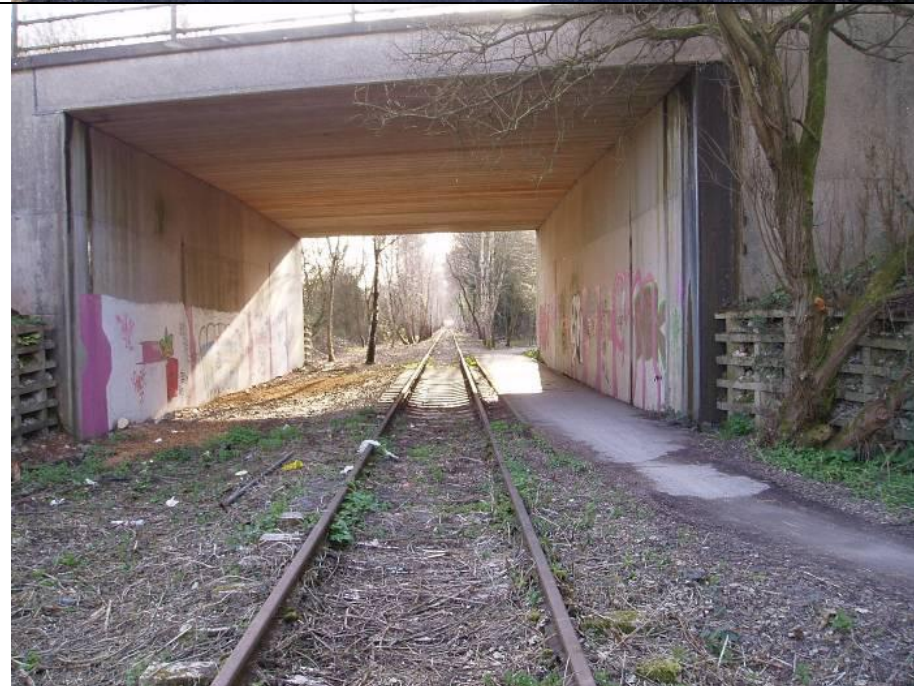
Photo 3260094

Under Royal Portbury Dock Road bridge, looking towards Portishead.

A much more modern structure, built to carry heavy dock traffic. Note; concrete, not wooden sleepers, laid when the bridge was built.

The pedestrian/cycle path is on the right.

There's no restricted access to the line here either.

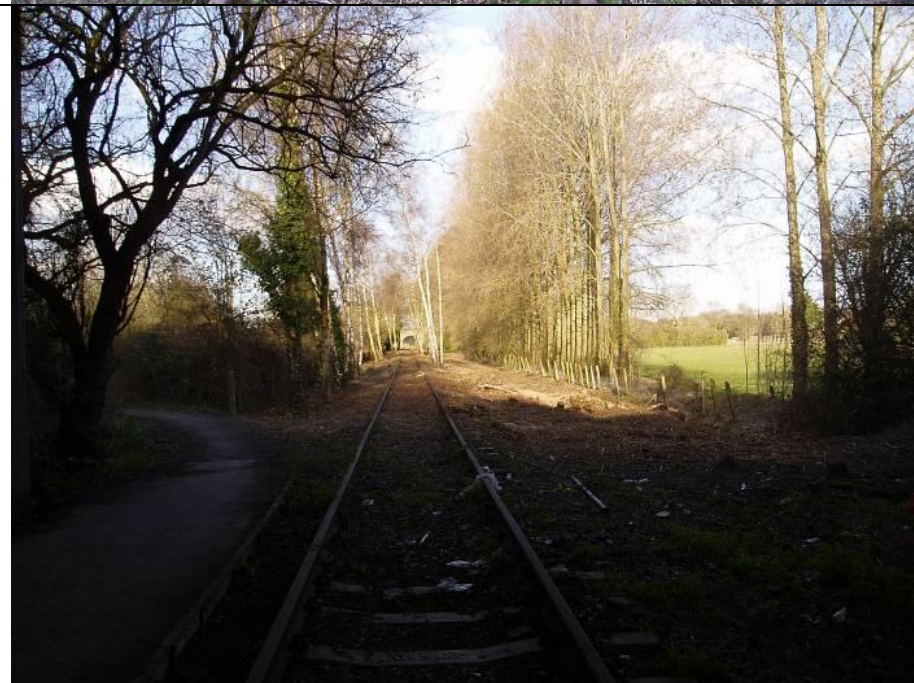
Photo 3260095

In the shadow of the Royal Portbury Dock Road bridge, looking back towards the Marsh Lane bridge, a sun-lit arch spanning the track in the distance.

The pedestrian/cycle path sweeps in from the left to run alongside the track under the Royal Portbury Dock Road bridge.

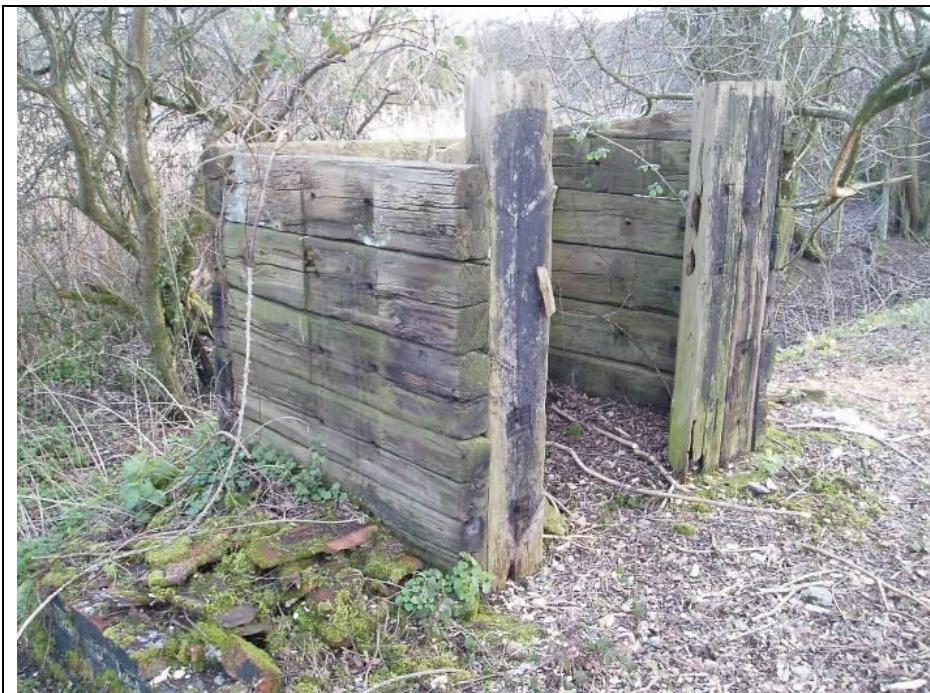
Photo 3260098

A charming remnant of yesteryear. A track ganger's hut by the looks of it, made out of old sleepers, many of them in far better condition than the ones on the track-bed, supporting the rails!

The rake of the roof-line can be seen in the sloping cut of the top sleeper on the far side (the slope-cut sleeper on the near side is missing). The old roof-tiles are in a heap by the near side.

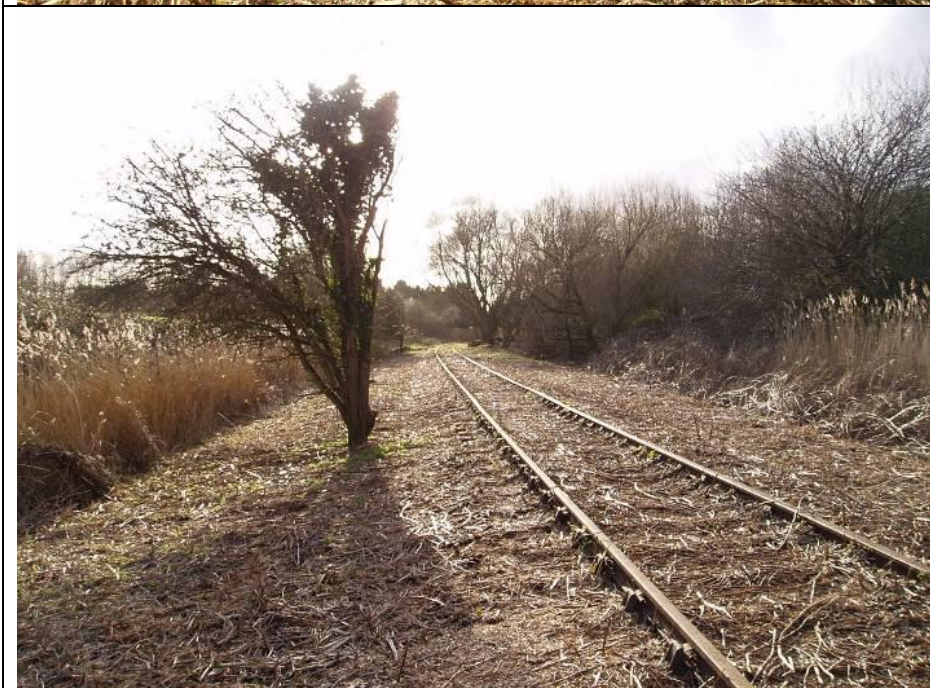
Photo 3260101

The view towards Portbury Station, which is just visible on the right-hand curve in the distance, marked by the wooden fence that has been erected along the old platform edge.

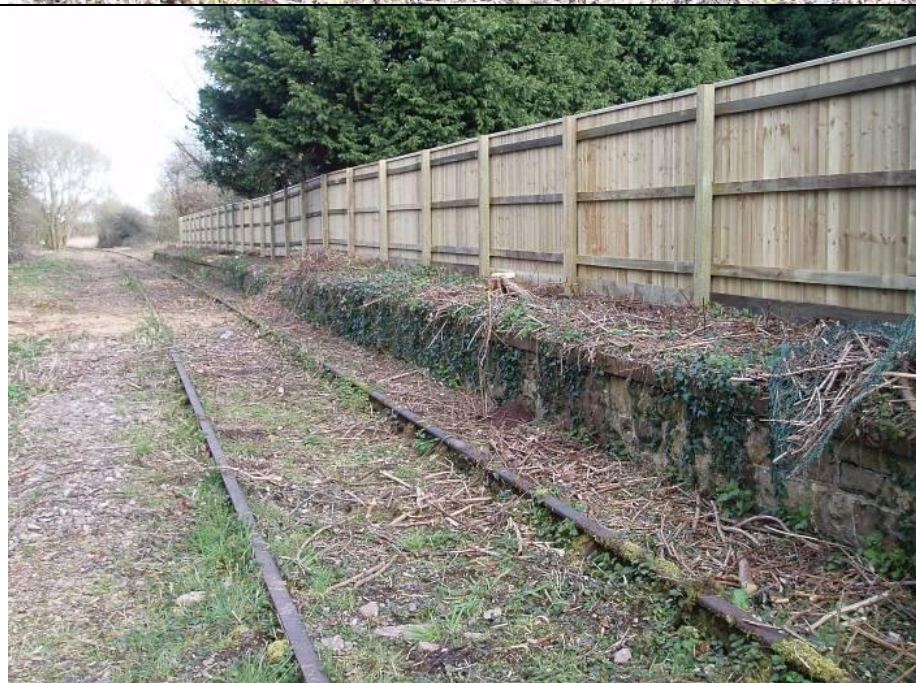
The crumbling, ivy-clad platform at Portbury Station, looking back towards Pill.

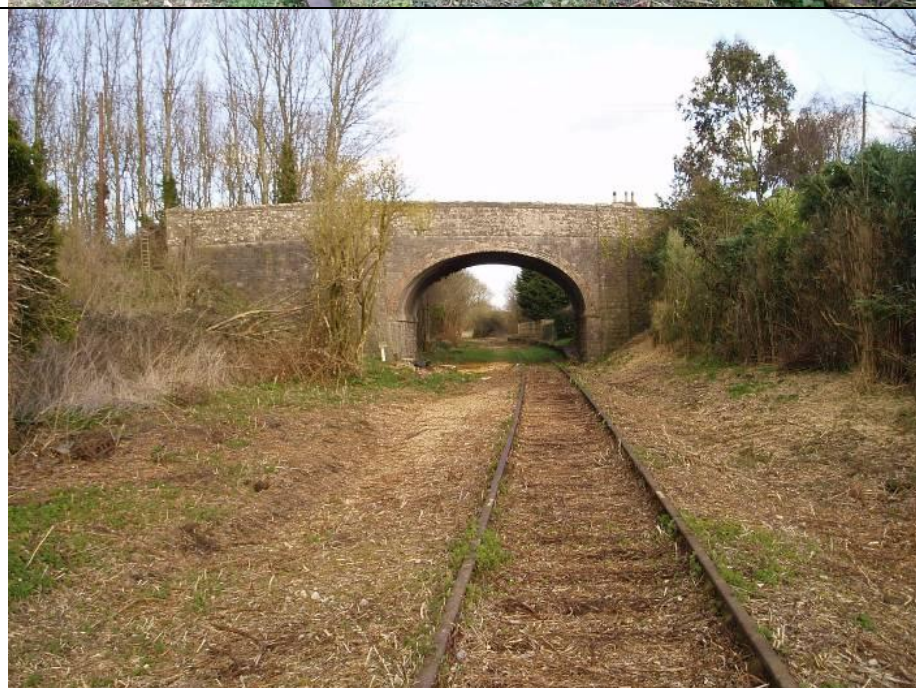
Photo 3260106

The view on the Portishead side of the Station Road bridge looking back towards Pill.

The platform of the old Portbury Station is clearly visible on the right, beyond the bridge.

This is the second of three old heavily engineered GWR bridges that remain along the line, again wide enough for two broad gauge tracks.

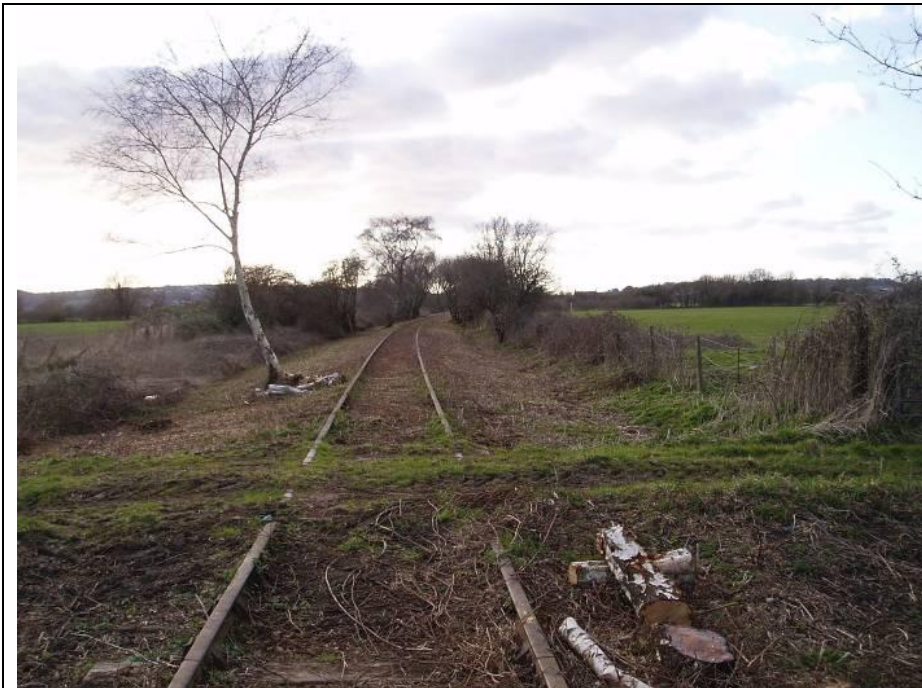
Photo 3260107

A farm crossing to fields on the left, from Elm Tree Farm in Sheepway, to the right.

One of at least 7 farm crossings along the 2¾ mile stretch from Pill Junction to Portishead.

Old maps show 7 such crossings but there is evidence of there having been 8 farm crossings between Pill junction and Portishead.

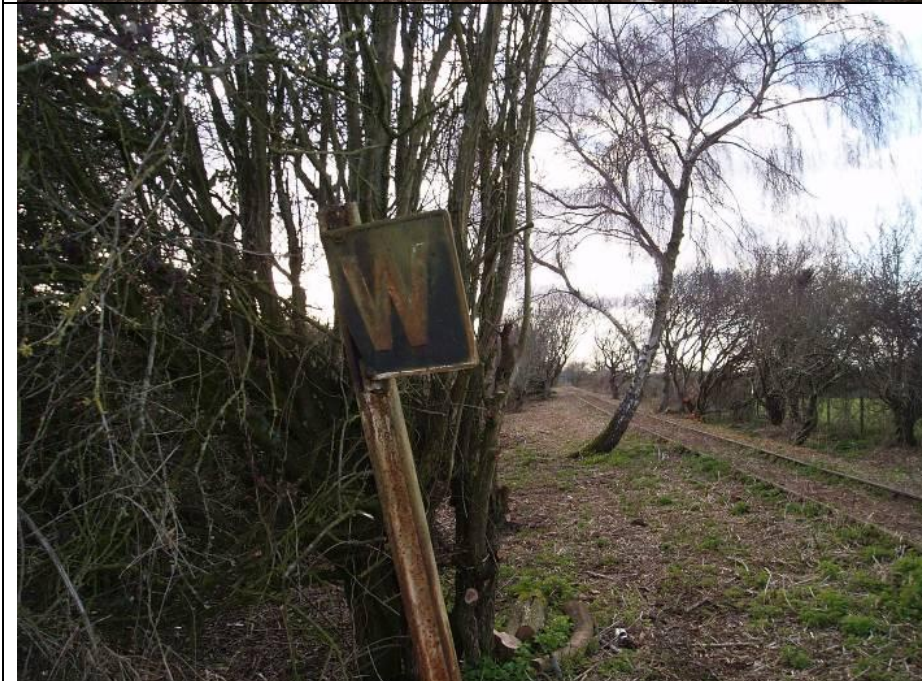
Photo 3260110

The remains of a sign that once upon a time would have said "SW". Back in the day, this would have meant "Slow. Whistle." A very necessary instruction to the driver due to the many farm crossings!

What's that white thing to the right of a small log? (see the next photograph)

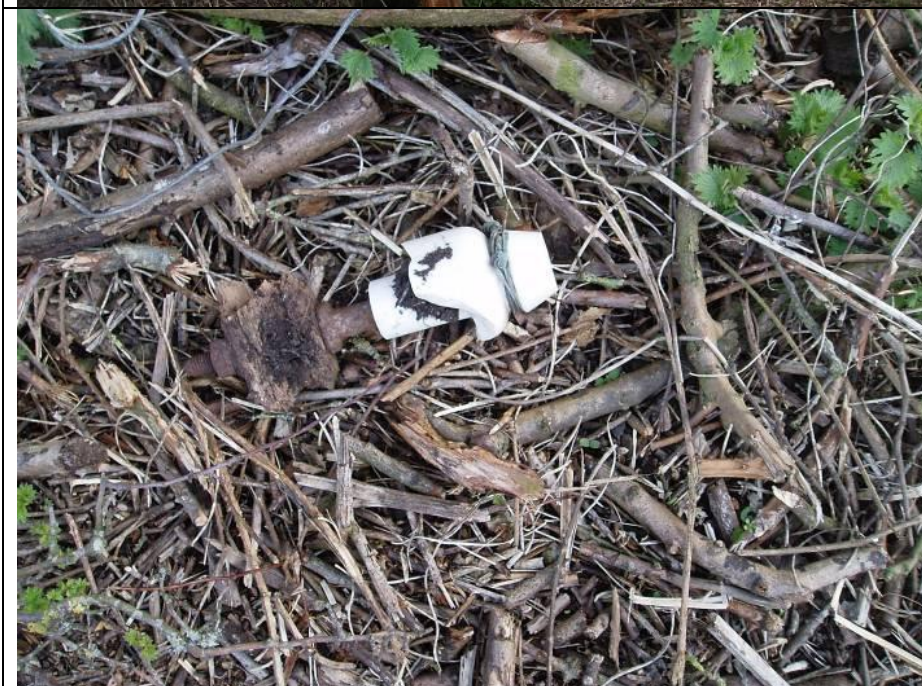
Photo 3260111

Railways usually had telegraph poles alongside the line, with telephone wires slung from pole to pole.

The wires were bare (uninsulated) tinned copper wire, wound around porcelain insulators mounted on wooden cross-bars towards the top of each pole.

Here's a porcelain insulator that has seen better days! But the wire is still in good condition.

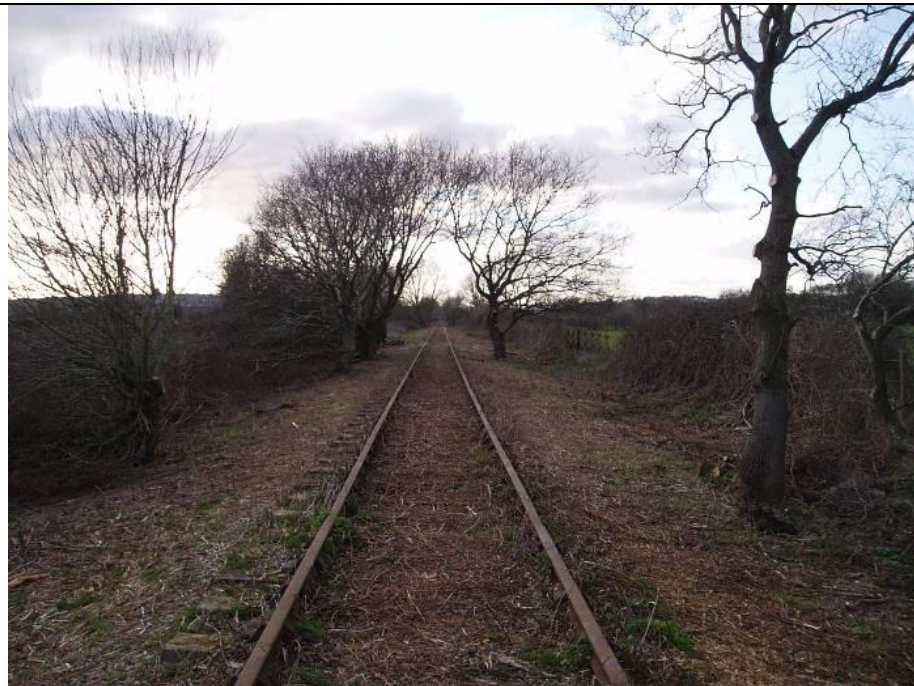
Photo 3260112

This is the beginning of the 1¼ mile dead-straight run to Portishead.

In the very far distance, the road bridge at Portbury Common on the Portishead to Sheepway road can just about be seen.

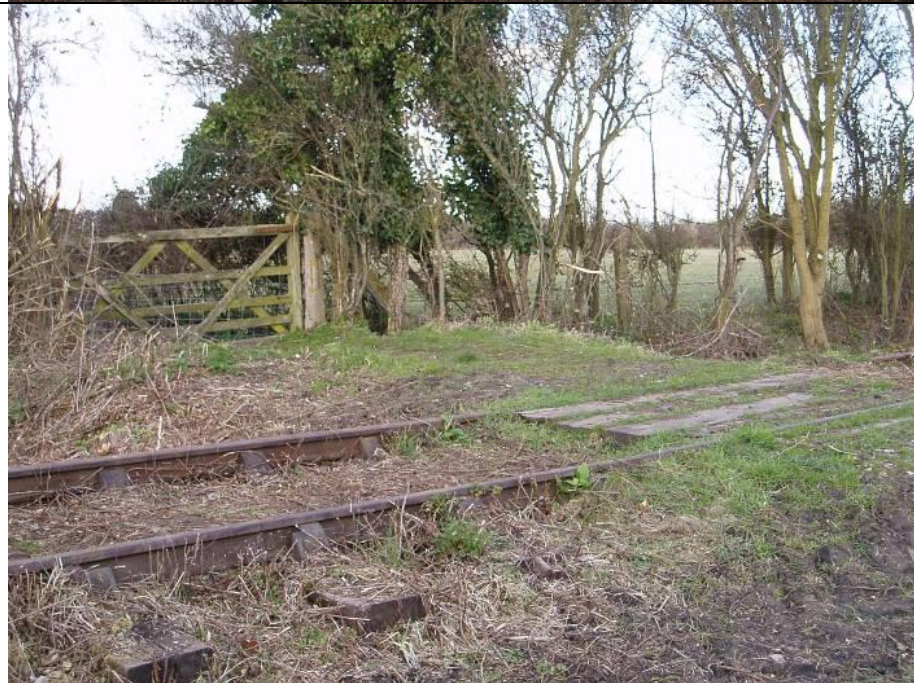
Photo 3260115

The first of two farm crossings linking fields belonging to Sheepway Gate Farm.

This farm crossing connects two odd-shaped fields which an old map shows was a single field before the railway was built across it.

Following reinstatement of the line, no farm crossings will exist, as all line crossings are considered to be unacceptable sources of danger.

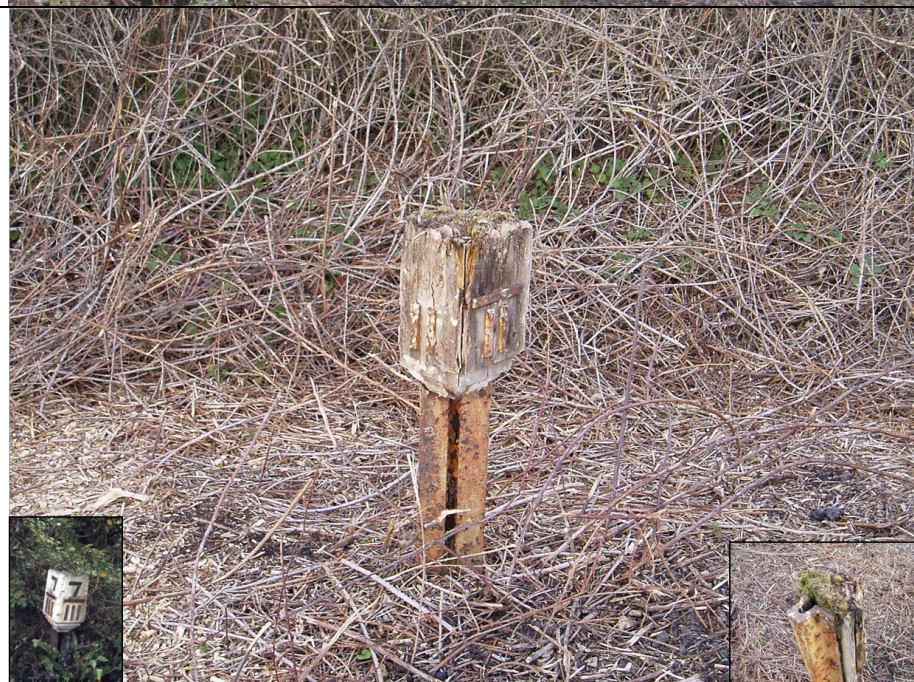
Photo 3260116

This was the marker-post showing 128½ miles from Paddington.

The numbers of miles (128) above the horizontal bars are missing, though the bar on the right is still in place. The "11" below the bar means "2 quarters".

The inset pictures show roughly what it once looked like and also that it is set on a post made from a piece of old broad gauge rail.

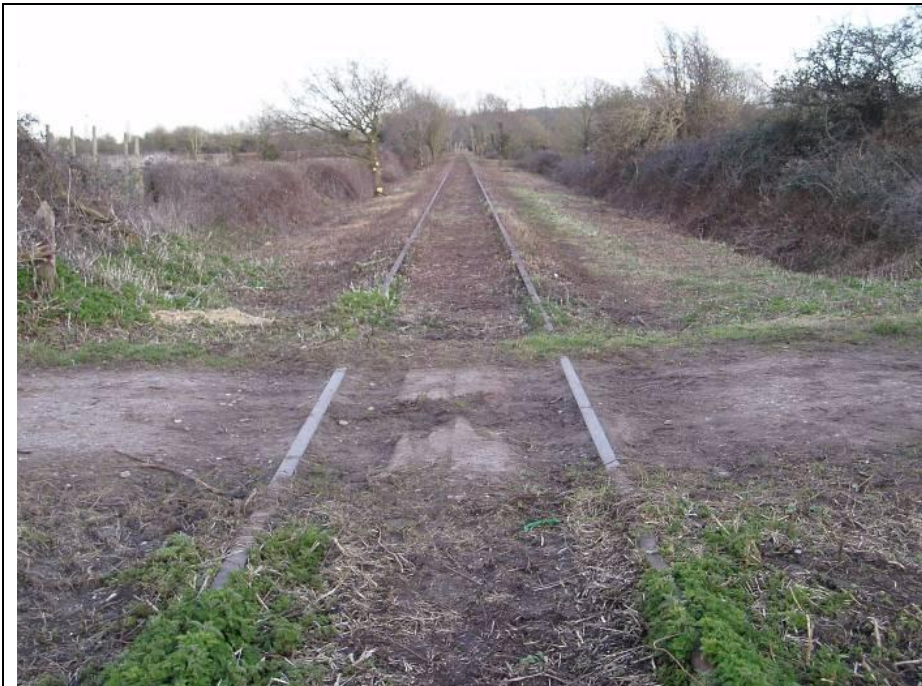
Photo 3260119

The still much-used Sheepway Gate Farm crossing.

This farm crossing will be replaced by a bridge, to provide continued safe access across the line.

This is the only farm crossing that will be replaced by a bridge. All others will be closed, permanently.

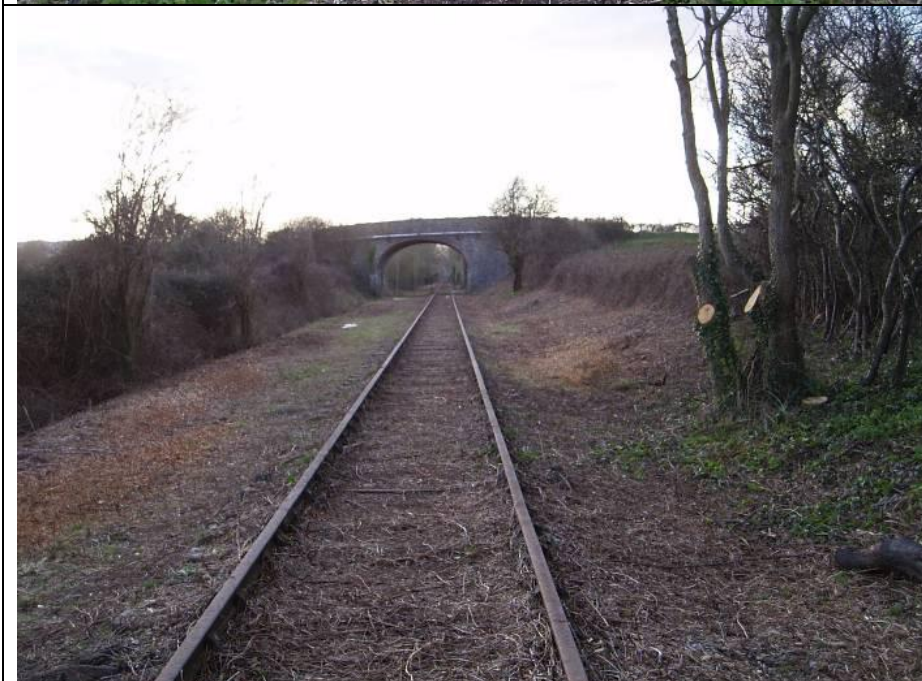
Photo 3260121

The third of the heavily engineered GWR bridges that remain over the line. Note the permanent way width: wide enough for two broad gauge tracks.

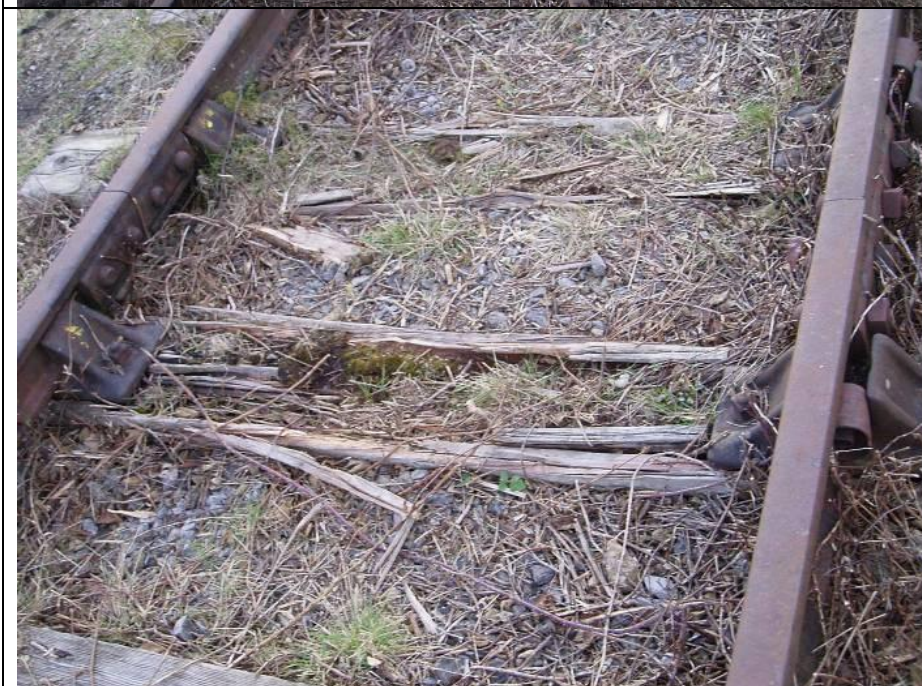
Photo 3260122

As with all lines that use wooden sleepers, a continual programme of replacement is required. If not.....

The ones shown here are very old indeed and may have been laid in the late 1940s, following nationalisation, maybe earlier.

The rail keeper at the right-hand side of the photograph needs hammering into place! Much more track movement and it will spring out!

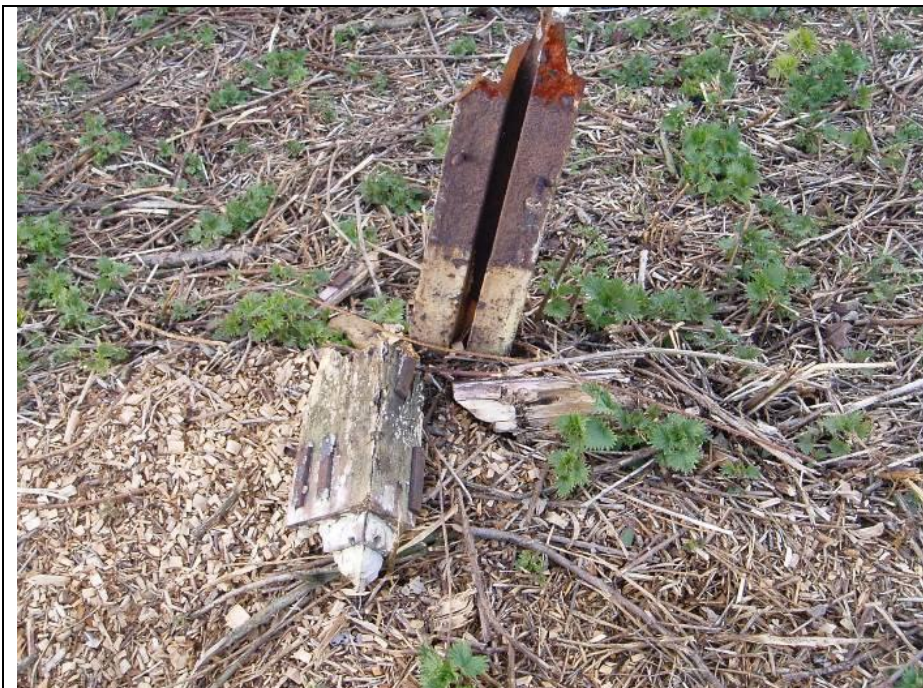
Photo 3260124

The remains of the 128¾ mile marker-post.

The two faces used to show the "111" meaning "3 quarters"; you can see where the missing "1" was placed. The horizontal bars are missing but you can see the bottom-half of "1" (of 128) on the right-hand side.

The post had been recently shattered (the characteristic deep orange of fresh rust) by the chain-flail that was used to clear the line.

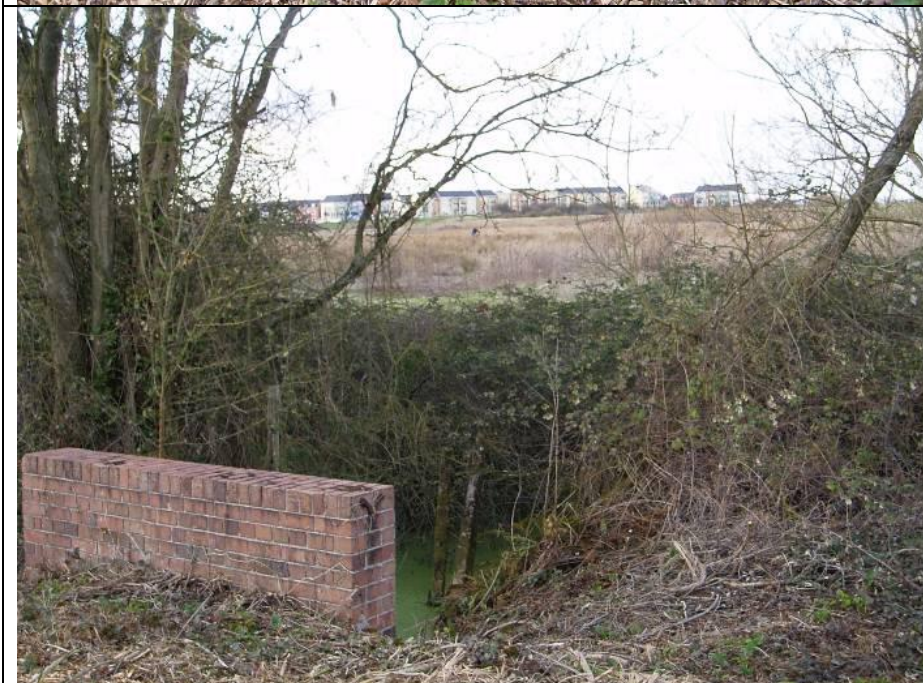
Photo 3260125

One of numerous culverts carry rhynes under the permanent way.

This one looks like it was re-built in the late 1940s maintenance works carried out along the line, following nationalisation.

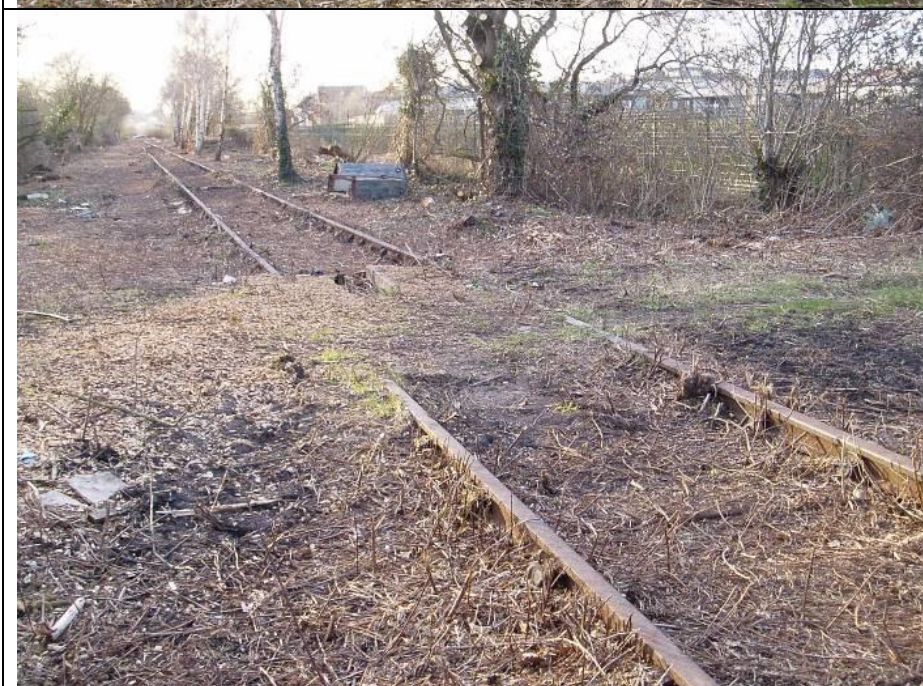
Photo 3260131

Moor Farm had at least two crossings, to gain access to its fields after the line was built in 1867.

The farm-track over this major crossing once stopped about 350m north of here at a section of the old sea wall which ran roughly along the east-west course of The Finches, towards Phoenix Way.

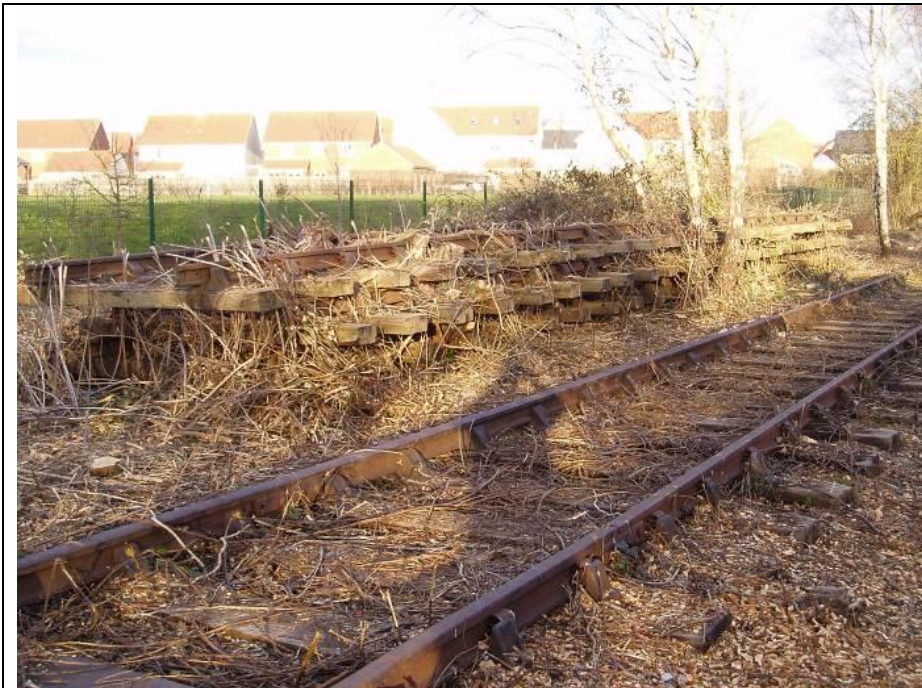
Photo 3260133

The line was “strategically important” due to Portishead Dock but also because of the oil tanks that were sited to the north of Wyndham Way until about 1990.

At some point, some track-works had been carried out but the various track sections were stacked, perhaps for future repairs etc.

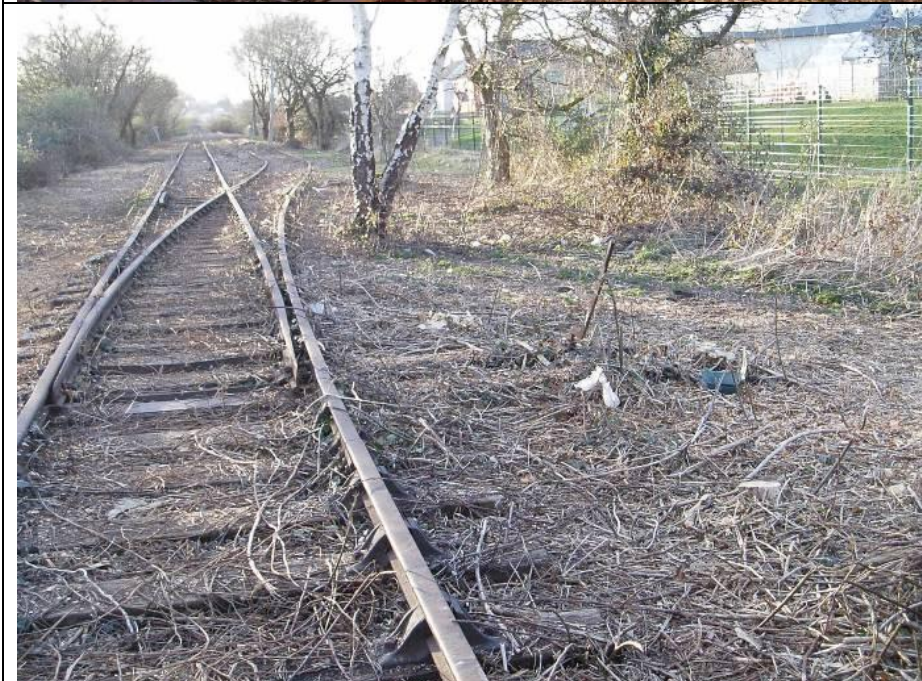
Photo 3260134

The single track becomes doubled to form a passing loop. The points operating lever is to the right of the line, beyond a piece of rubbish.

The passing-loop was laid to cope with the GWR150 celebration train that ran down the line but actually formed a loop that should have been installed following closure of the line to freight in 1981.

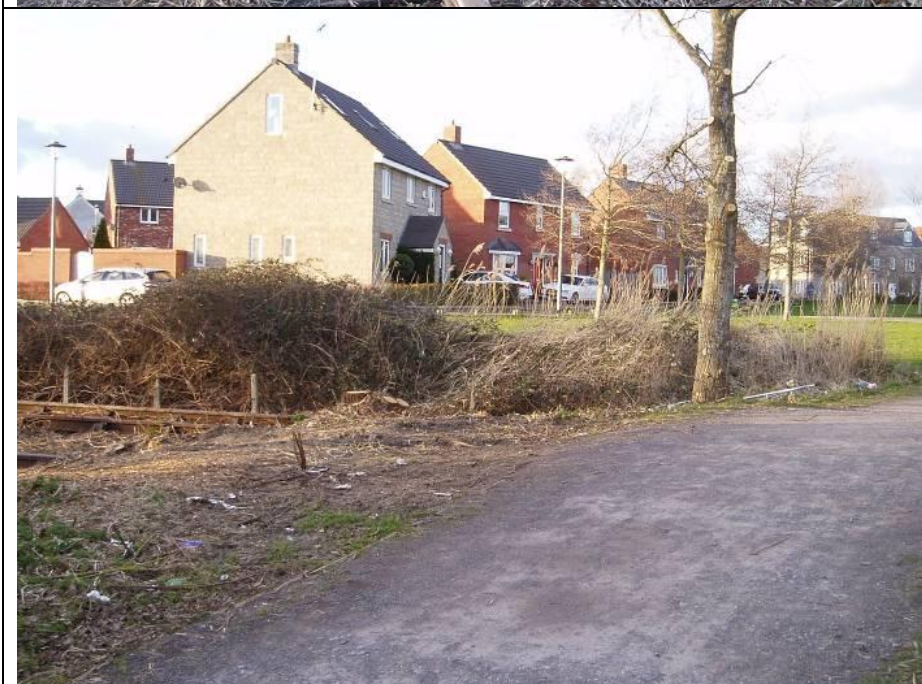
Photo 3260138

The well-used permissive crossing between The Vale and The Village Quarter, near Trinity School.

“Permissive” means “not permanent” and it is intended this crossing will be replaced by a full-access pedestrian bridge.

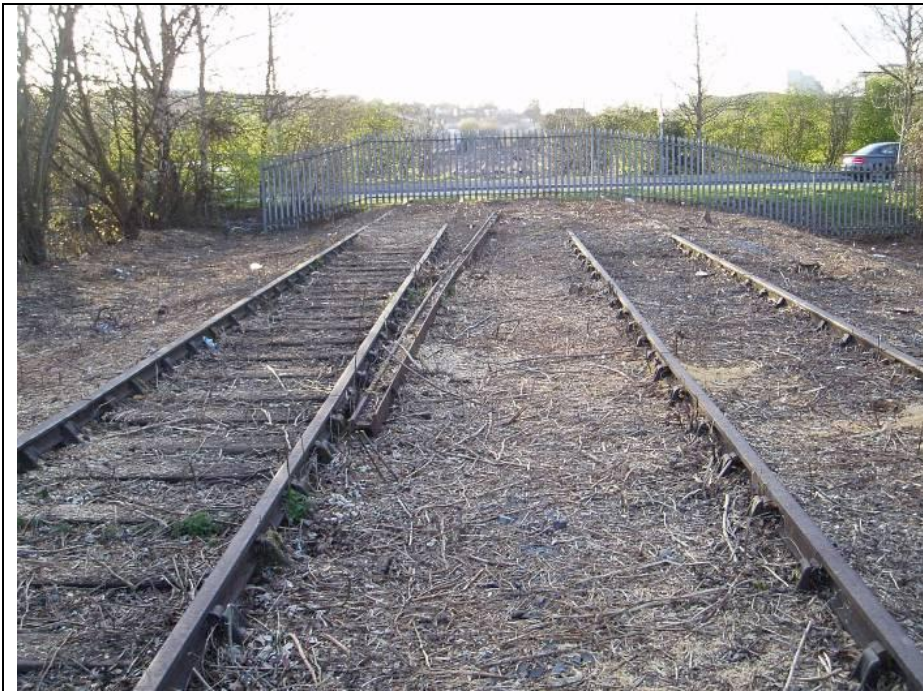
Photo 3260140

The raised road-bed of Quays Avenue, originally to support the future installation of a level crossing, sits just the other side of the fence.

This shot was taken from roughly halfway down the future platform.

No new level crossings are allowed, unless there are exceptional circumstances, hence the proposed re-layout of Quays Avenue in the plans for the new station and access to it.

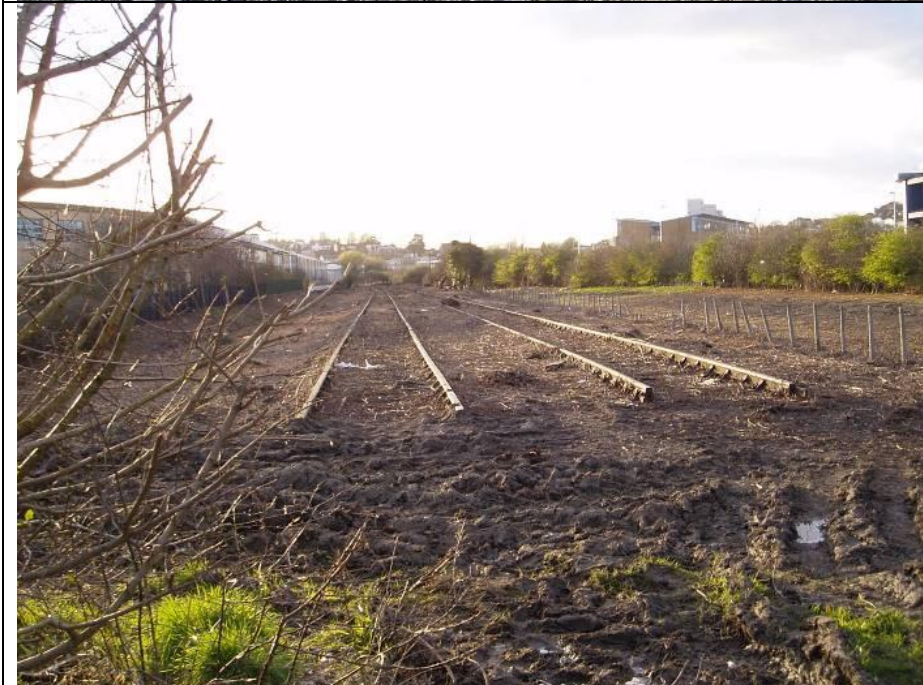
Photo 3260142

Looking towards the site of the old (1954) station, this is where the sidings were once situated.

The re-routed Quays Avenue will run across this land, with the car park and pedestrian walkway beyond.

The photo was taken roughly where the platform will end and the station building will begin

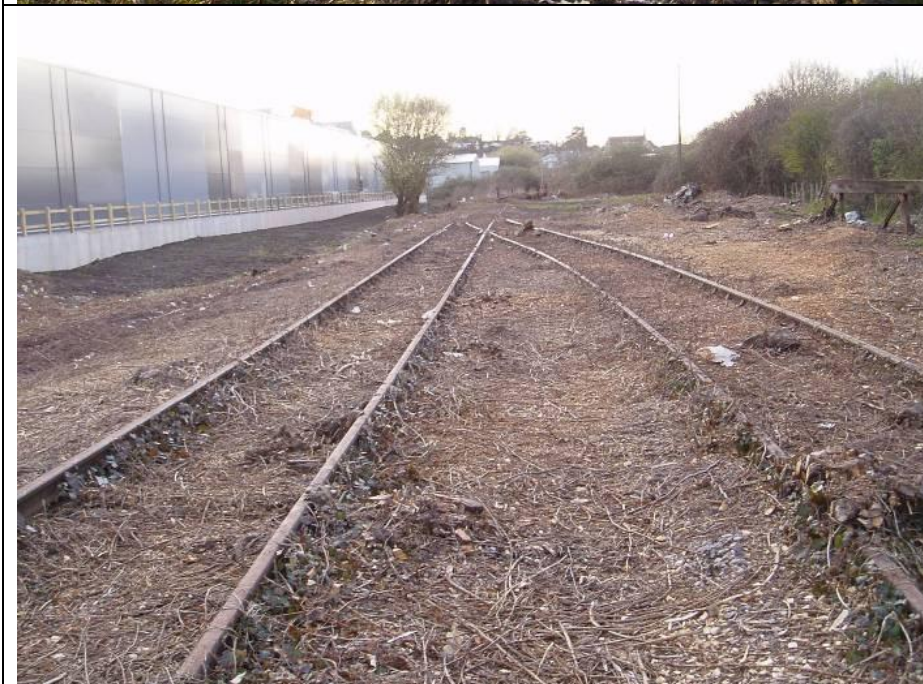
Photo 3260145

The twin tracks converge at points near the end of the line. These points and the previous points provided a “run around” track for a locomotive.

Note the lone buffer at the right-hand edge of the photo; the sole remaining hint that many sidings were once around here.

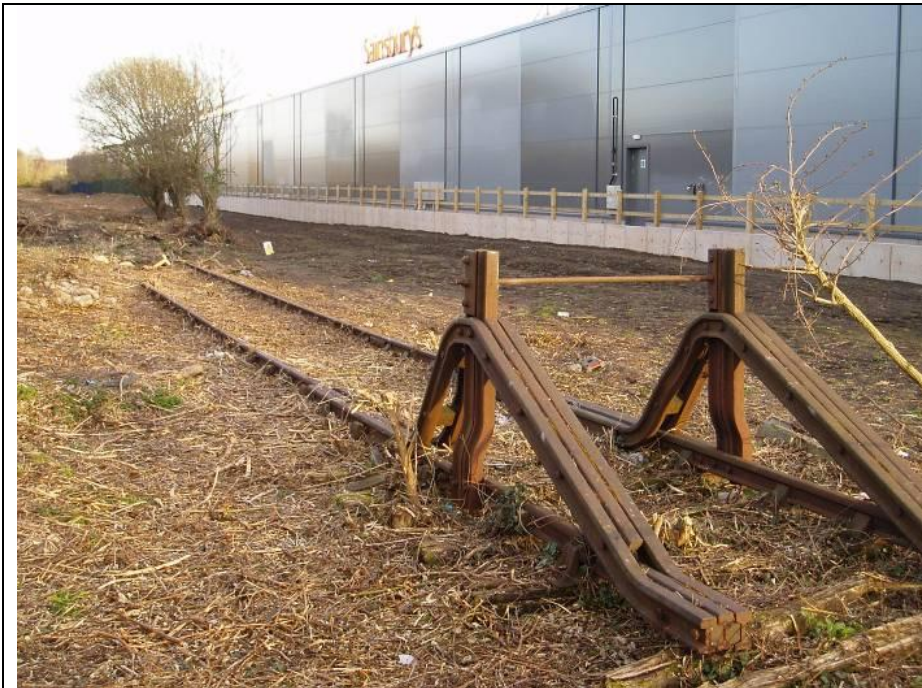
The end of the line, with the Sainsbury's store in the background.

Looking in this direction up until the early 1990s, you would have seen the oil-tanks with their surrounding earth ramps.

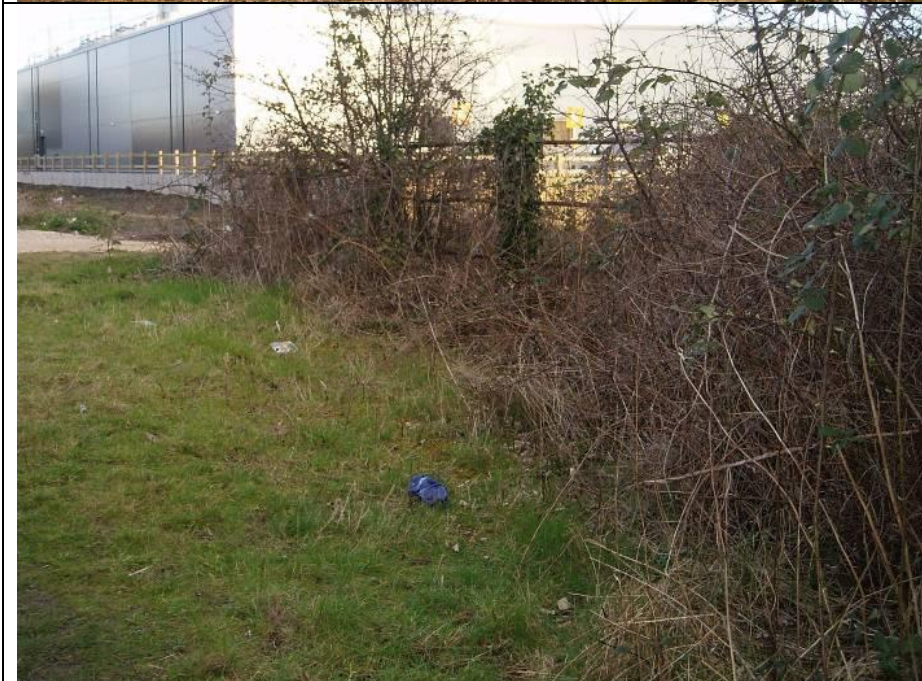
Photo 3260151

The south side of the railway bridge across the rhyne, with Sainsbury's in the background.

The bridge used to carry twin tracks into the platforms and some of the many sidings at Portishead station.

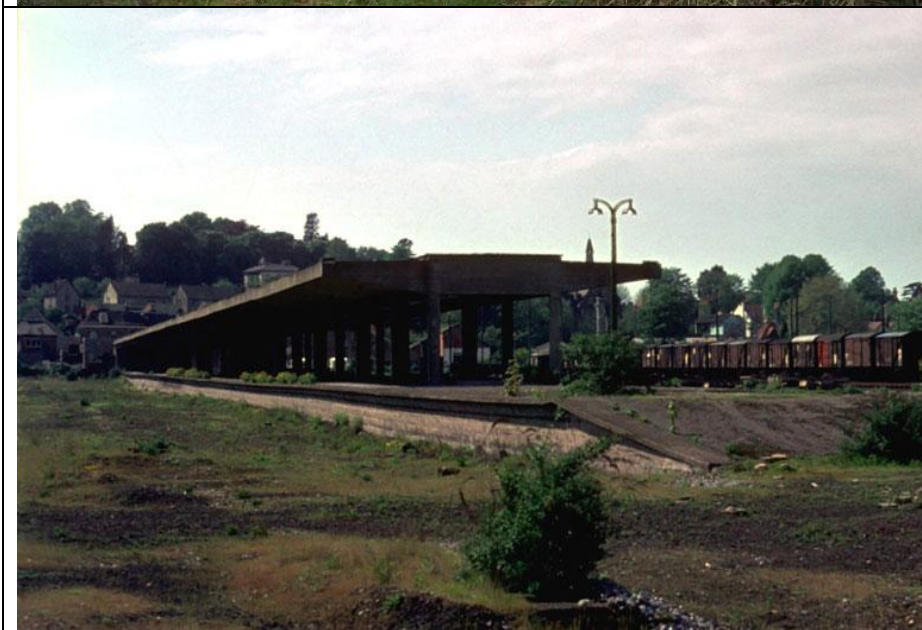
The railway ended at the 1954 Portishead station and the sidings to the north of it.

The picture (from the Internet) was probably taken in the late 1960s or early 1970s, after closure of the railway to passenger traffic in 1964 but before the station was demolished.
